# Case Study

## Process Optimization Through Six Sigma Methodology

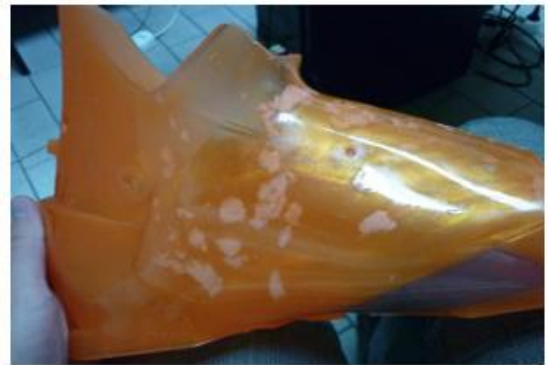
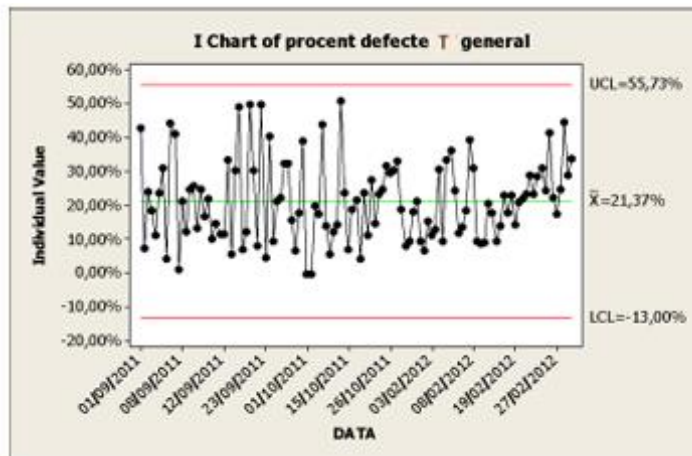
- The client was experiencing a high incidence of cosmetic defects on one of their products.
  - These defects originated during the plastic injection molding process performed on a vertical injection machine
-

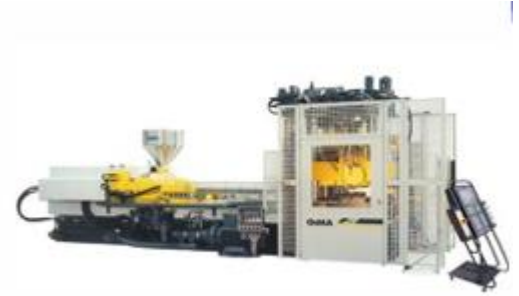
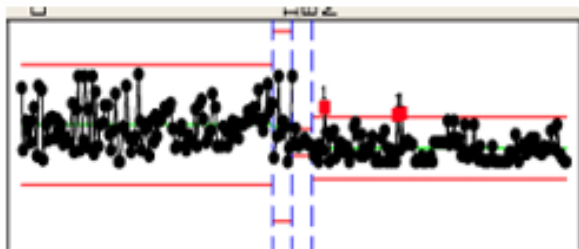
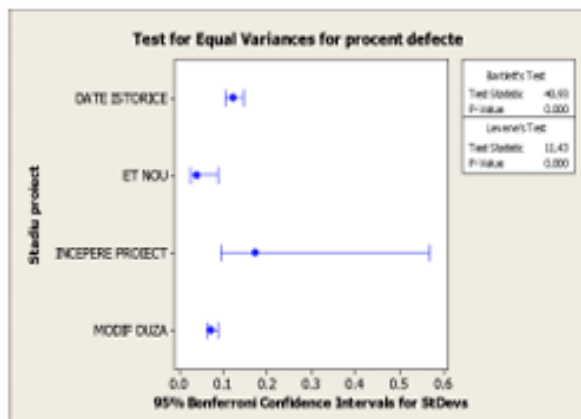
- Using the control chart, it was observed that after implementation, the average defect rate decreased from 21% to 8%.
- Hypothesis testing tools were used to demonstrate whether the improvement was statistically significant.
- It was thus proven that, after the final implemented measures, the improvement is statistically significant
- Recalculated annual savings: €32,500

- For the machine: the injection rod length was adjusted.
- For the suppliers: the supplier was changed.
- Other measures: periodic checks of the humidifier and periodic verification of the inspection accuracy
